Whitetopping Performance in Illinois

FINAL REPORT
PHYSICAL RESEARCH REPORT NO. 148
JANUARY 2005

Illinois Department of Transportation

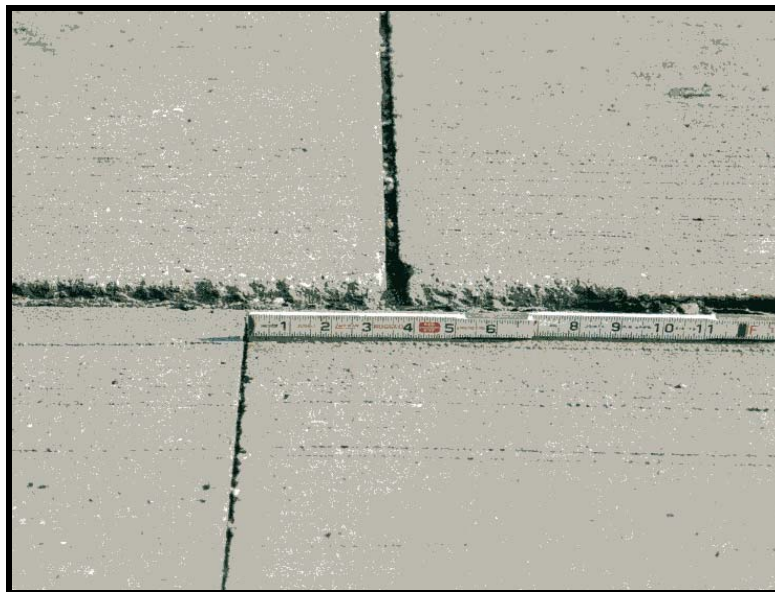
Figure 1
Whitotopping Panel Shifting

This project has shown one very peculiar distress during the evaluation period. The panels of the driving and passing lane which are considered ultrathin whitetopping are shifting and “growing” uphill towards the intersection. The panels adjacent to the curb which are considered a bonded inlay are not shifting. The current belief is that as traffic approaches the intersection and slows to a stop, they are shoving the whitetopping through the intersection. As can be seen in Figure 1 below, the amount of accumulated movement of the whitetopping compared to the bonded inlay was nearly four inches at the close of the evaluation period. This type and amount of movement would suggest that the entire inlay is debonded and moving; however, the sounding test indicates otherwise. It is believed that the failure plane may be within the underlying HMA layer. If so, the HMA may be shearing without any debonding from the whitetopping inlay. Further evaluation of this phenomenon is recommended when the intersection is eventually removed and rehabilitated.

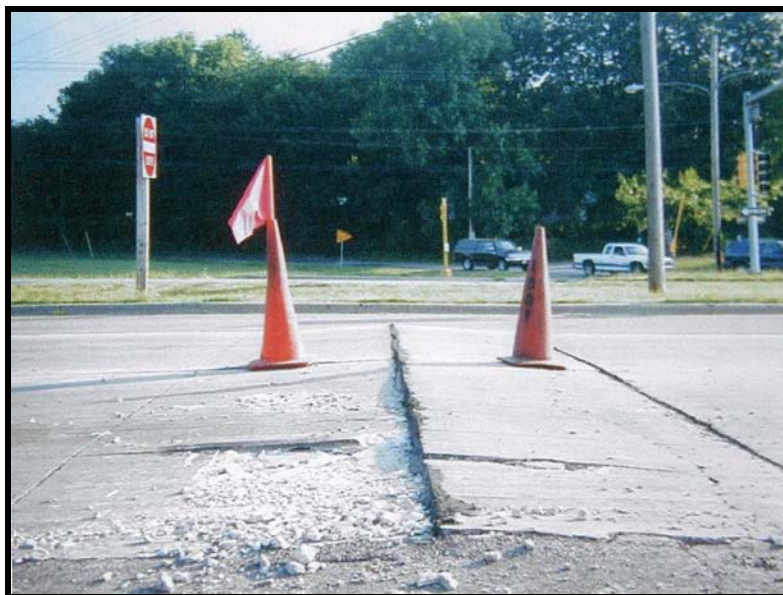
Figure 2
Bonded Concrete Inlay “Blow-Up” Failure

Two large patches have also been placed on this project due to isolated and unrelated failures. The first patch was placed in August of 2001, just three years after construction. This patch occurred in the westbound driving and passing lanes at the location of an old traffic indicator loop in the original concrete pavement. The concrete inlay appeared to heave or “tent” at a full-depth relief joint as can be seen in Figure 2. The appearance of the failure gives evidence that this may have been a pavement “blow-up” due to hot summer temperatures and increased thermal expansion of the concrete inlay.

The concrete inlay was removed with a backhoe and a HMA patch was placed by IDOT maintenance forces. The completed patch may be seen in Figure 3. This HMA patch was still performing very well at the end of the evaluation period.

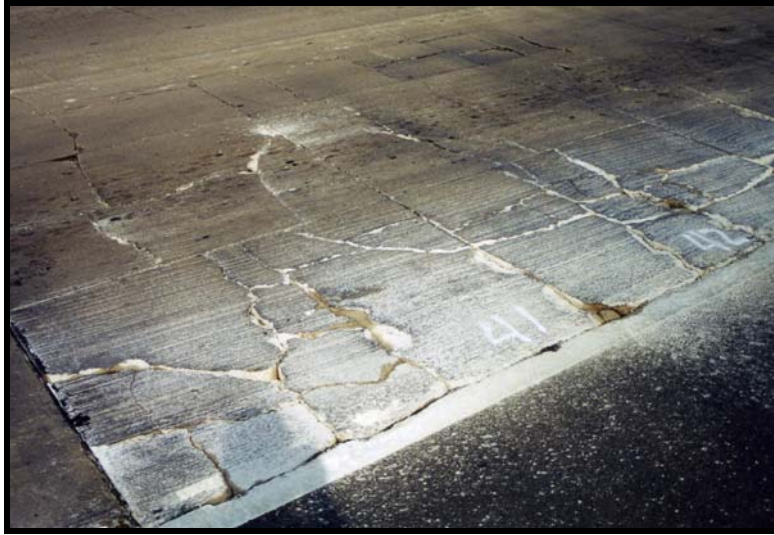
Figure 4

The second patch was placed in the eastbound driving lane just prior to the traffic signal. This patch was placed in October of 2001 and consisted of a full-depth removal and replacement. The concrete inlay at this location experienced high severity distress and debonding soon after construction. By the fall of 2001, this area was becoming a hazard to the traveling public and required replacement as can be seen in Figure 4.

The cause of this failure is believed to be construction related. The eastbound driving lane was placed the day after a rain event which left standing water on the pavement and in the full-depth patches as shown in Figure 5. The area of this patch is immediately following a full-depth patch placed during construction. Construction photos and documentation indicate that the rain water was not pumped from the patch locations, but rather forced out by the plastic concrete. This excess water on the existing pavement reduced the bonding capabilities of the concrete inlay, and was worked into the plastic concrete reducing the strength of the concrete inlay.

Distressed Bonded Concrete Inlay Prior To Patch

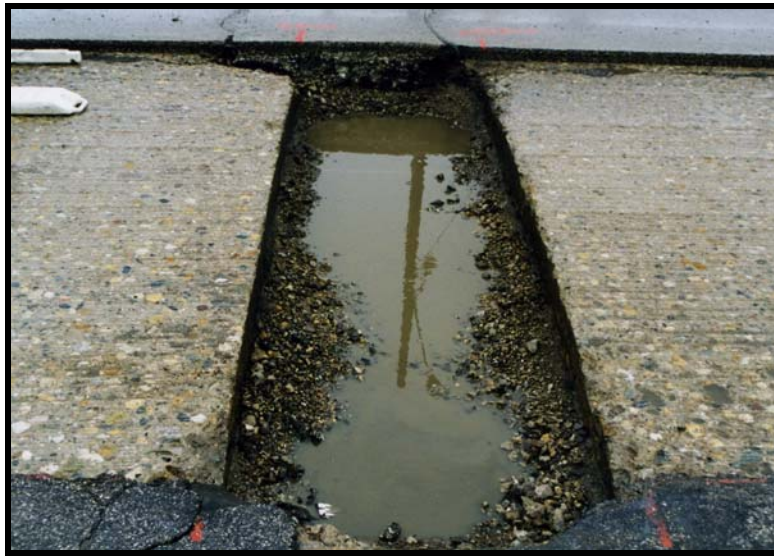
Figure 5

Water Standing In Full-Depth Patches During Construction

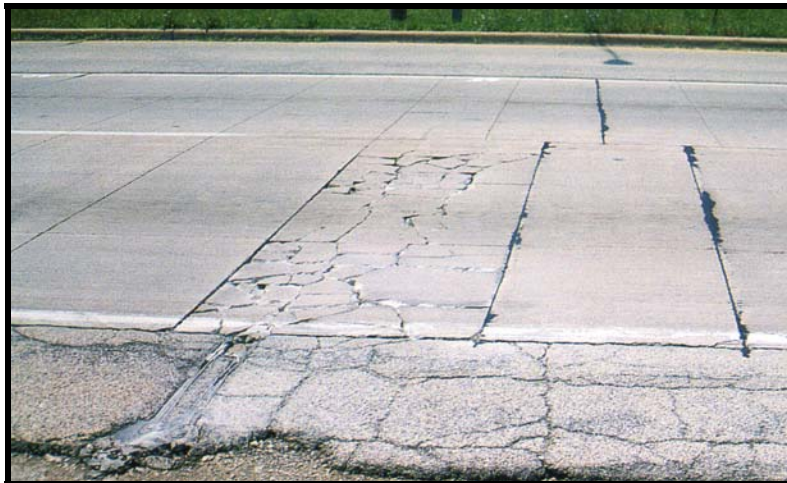
Figure 7
Distress at Traffic Indicator Loop

This project has also displayed a significant number of additional distresses that should be noted. The most prominent of these is the occurrence of high severity cracks in the concrete inlay at the location of an existing traffic indicator loop which was left in place. An example of this may be found in Figure 7. Secondly, the majority of the cracking distress noted was transverse mid-panel cracks versus the more traditional corner break cracks associated with whitetopping. Finally, those distressed panels which were not merely mid-panel cracked were cracked in several random directions. The majority of the panels with this type of distress occurred at the pavement centerline, which also served as the longitudinal construction cold joint.

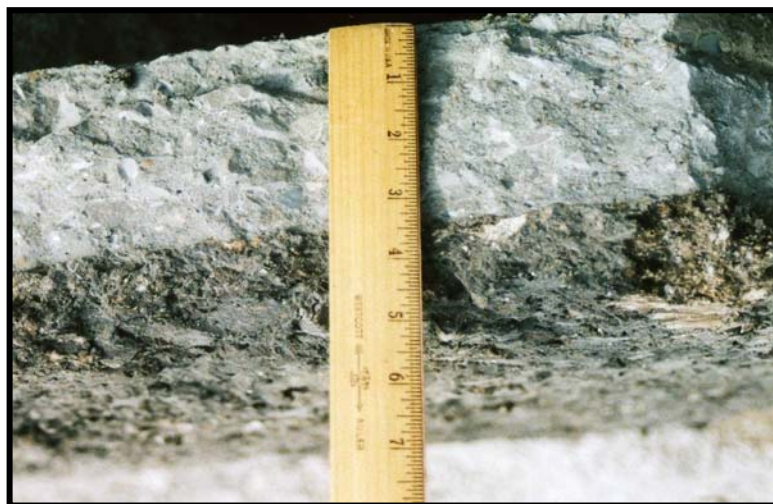
Figure 8

As stated before, this project was removed from service in August of 2002. Observations were made of the removal process to document the bond of the whitetopping and bonded concrete inlay sections. Removal was completed in sections to accommodate the traffic flow on U.S. Highway 51 during the realignment project. The outline of each section to be removed was first cut with a wheel saw and then removal was done with a backhoe. Both the whitetopping and bonded concrete inlay sections exhibited a good bond to the underlying pavement as pavement removal was difficult with the backhoe. Figures 8 and 9 indicate the bond and the amount of underlying pavement that remained attached to the concrete inlay.

Bond of Whitetopping to Underlying HMA Pavement

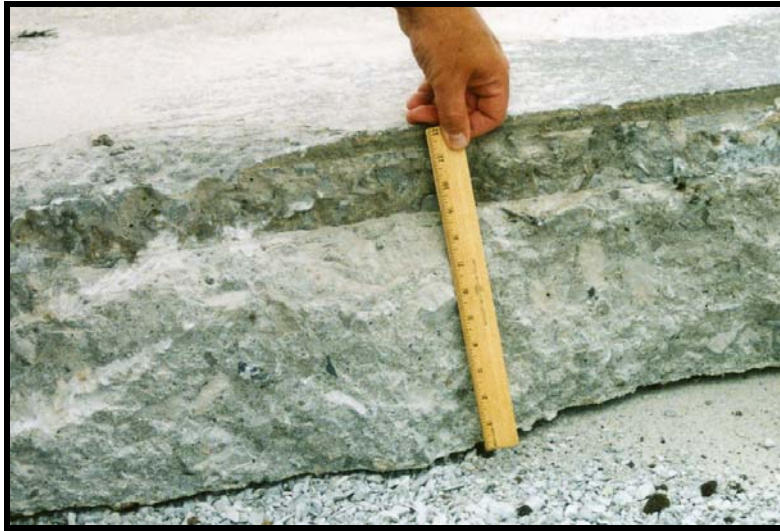
Figure 9

Bond of Whitetopping to Underlying Concrete Pavement

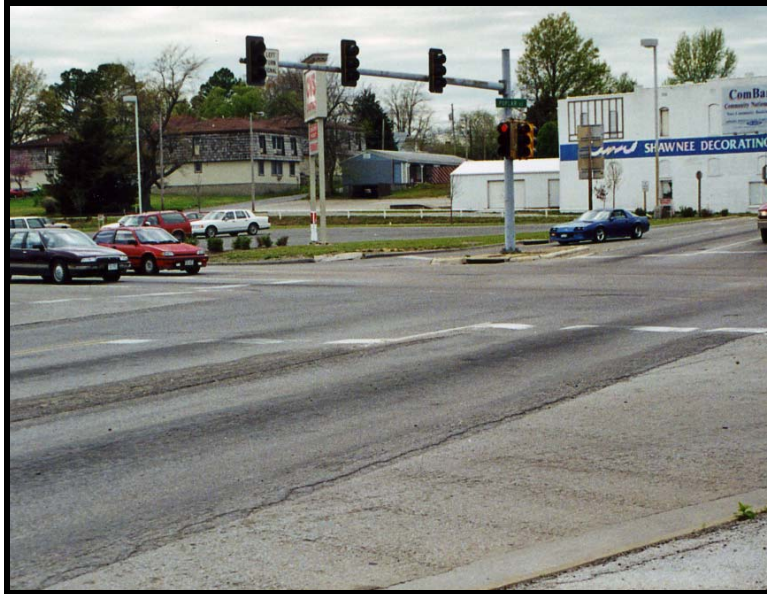
Figure 10
Existing Pavement Rutting

Transverse cracking, rutting, and shoving of the HMA overlay, were evident in all four legs of the intersection prior to this rehabilitation. Evidence of the rutting may be seen in Figure 10 below. The original pavement cross section consisted of a portland cement concrete pavement overlaid with a nominal 4.5 inches of HMA. This overlay was not present for the driving lanes of U.S. Highway 45 or the eastbound right turn lane on Illinois Route 13. These lanes were added to widen the intersection and consisted of full-depth concrete pavement. The complete layout of the Harrisburg project may be found in Figure 11.

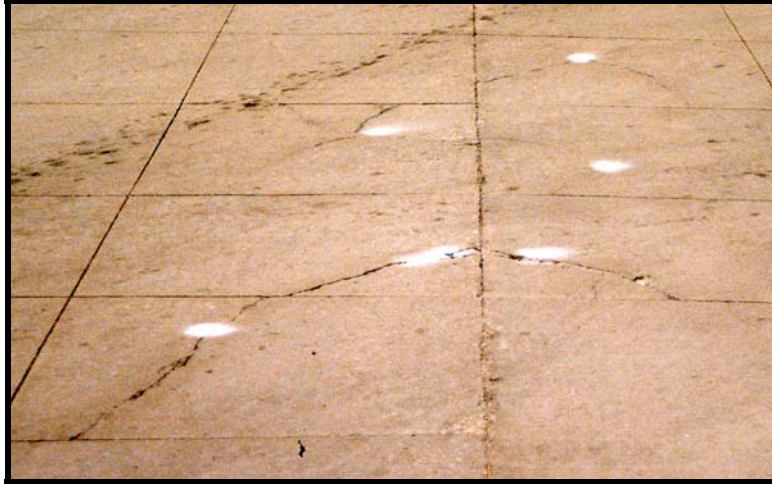
Figure 13
Harrisburg Whitetopping Area of Distress

This project has two areas of medium to high severity distress located at the center of the intersection. One area is located within the whitetopping inlay section and may be seen in Figure 13. This distress also happens to be centered around a construction joint between two stages. The second area of distress is located in the bonded concrete inlay section and may be seen in Figure 14. This distress is located in the westbound lane at the stop line for the intersection. Neither area of distress can be explained by an underlying distress in the original pavement prior to the inlay construction.

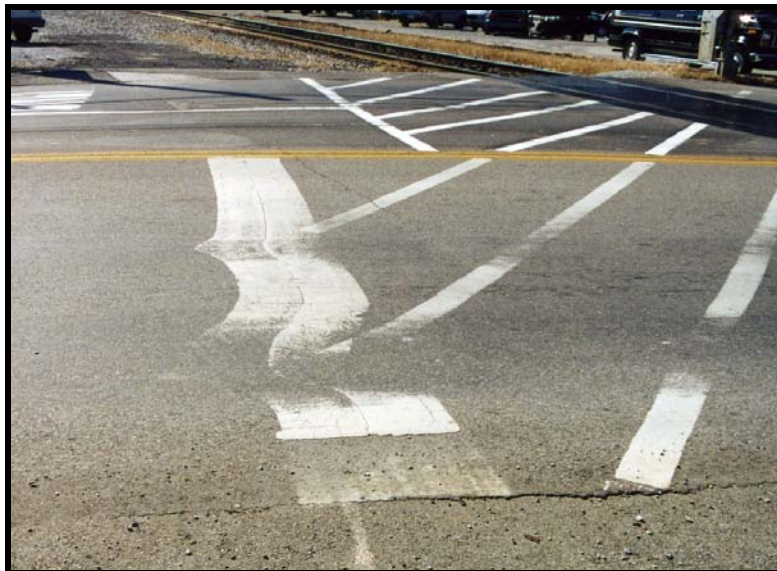
Figure 16
Rutting at the Stop Line

Rutting and shoving of the HMA overlay were the major distresses noted at this intersection prior to the rehabilitation. The rutting was particularly bad in the area of the stop line as may be seen in Figure 16. The existing pavement at this intersection consisted of brick pavers with a variable thickness HMA overlay.

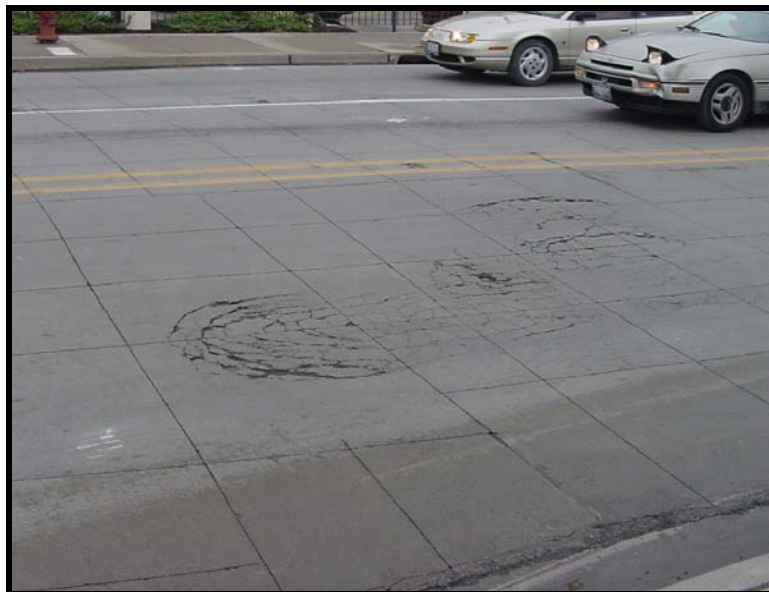
Figure 18
Anna Whitetopping Area of Distress

There is one area of high severity distress in the eastbound driving lane as seen in Figure 18. The area appears to be a slight depression; however, there is no noticeable deflection under the loaded axle of a tractor trailer. In addition, there is no evidence of an underlying defect in the original pavement at this area.
